Annual Report to Alaska Department of Environmental Conservation

Year 2009

Commitment to Corrosion Monitoring

Prepared by Corrosion, Inspection and Chemicals (CIC) Group BP Exploration (Alaska), Inc.

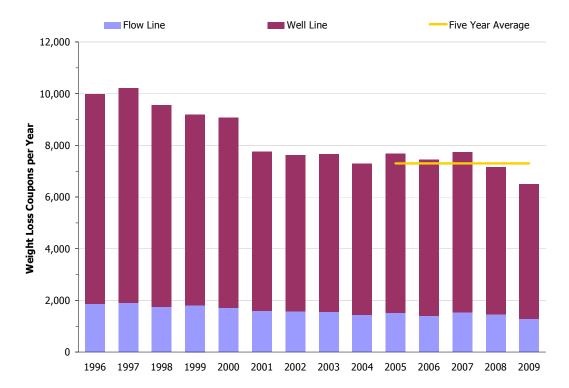
GPB Figure A.1 Corrosion Monitoring Activity Statistics by Equipment

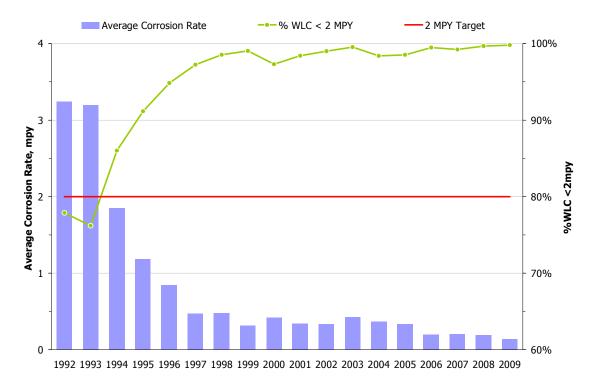
GPB Figure A.2 shows the average corrosion rate and percentage of coupons meeting the performance standard target since 1992. The results show that the percentage of conformant flow line coupons has continued to improve since 1992. In fact, the average WLC corrosion rate has been <0.5 mpy since 1997 and <0.25 since 2006. While the data clearly point to the success of mitigation efforts, such consistently low corrosion rate values approach the limit of practical and statistical significance for this monitoring method.

GPB Figure A.2 Flow Line Oil Service Corrosion Rate Trend

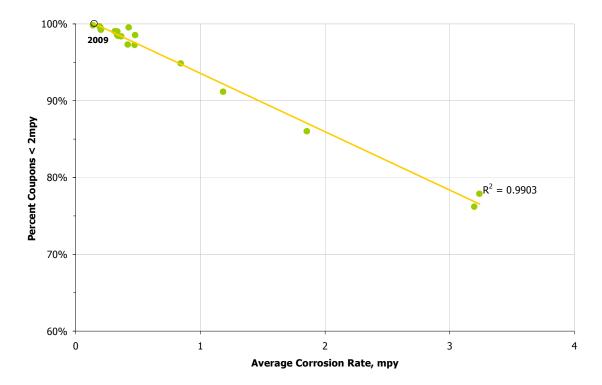
GPB Figure A.3 shows the correlation between average corrosion rate and the percentage of weight loss coupons meeting the 2 mpy target. As might be expected, there is a strong correlation between these two metrics. The average corrosion rate metric has the advantage of showing the overall performance trend for the system that would otherwise be lost when only looking at the exceptions >2 mpy. The value of exceptions is certainly not overlooked however, and all WLC corrosion rate exceptions are validated and addressed as needed.

GPB Figure A.3 Correlation between Flow Line Corrosion Rate and Percentage Conformance

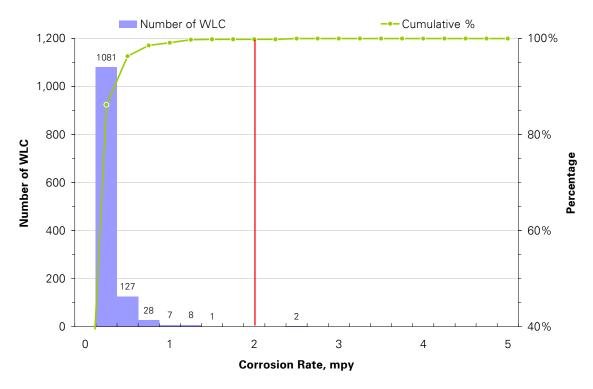
GPB Figure A.4 shows the distribution of corrosion rates for WLC in flow line oil service. Only two WLC in flow line oil service exhibited general corrosion rates above the 2 mpy target; the highest being 2.4 mpy. None of the coupons in flow line oil service exceeded the pitting rate target of 20 mpy. Results from coupon analysis are reviewed on a regular basis as new data is received. Corrosion rate exceptions are investigated and inhibitor increases or other mitigation steps may be implemented according to established protocols. Two corrosion inhibitor increases were performed based on flow line WLC exceptions. Refer to Section D.1.5 for details and corrective actions for WLC exceptions.

GPB Figure A.4 Flow Line Oil Service WLC Histogram

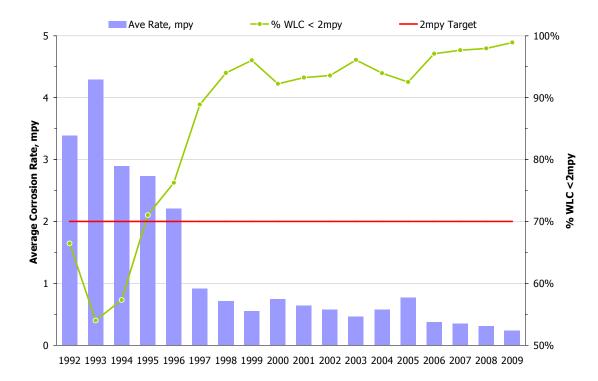
GPB Figure A.5 shows the average corrosion rate and percentage of WLC ≤2 mpy for well line WLC since 1992.

GPB Figure A.5 Well Line Oil Service Corrosion Rate Trend

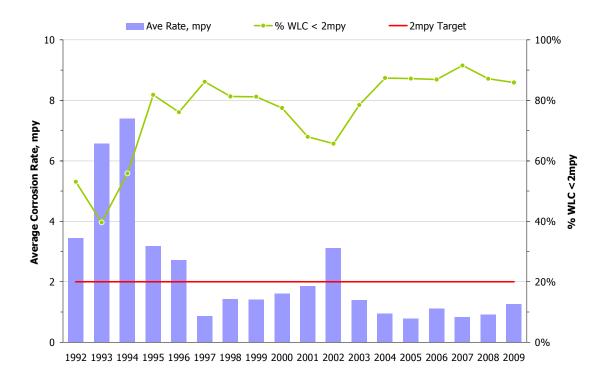
GPB Figure A.6 is a summary of aggregate data for produced water and seawater flow lines. The average WLC corrosion rate for produced water and seawater flow lines in 2009 was 1.3 mpy which is comparable to the performance of recent years but slightly higher than the average corrosion rate in 2008. The average pitting corrosion rate for WLC in the same PW and SW flow lines was 1.7 mpy and 99% of the coupons were below the 20 mpy target pitting rate.

GPB Figure A.6 Flow Line PW/SW Service Corrosion Rate Trend

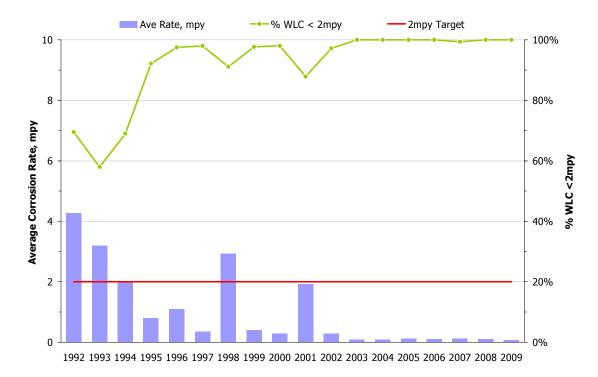
GPB Figure A.7 and GPB Figure A.8 summarize the historical corrosion rate data for produced water well lines. The data show general corrosion rates in the produced water system have fallen as the level of inhibition in the 3-phase system was increased and after supplemental produced water corrosion inhibitor injection was initiated.

GPB Figure A.7 Corrosion Rate Trend for 100% PW System

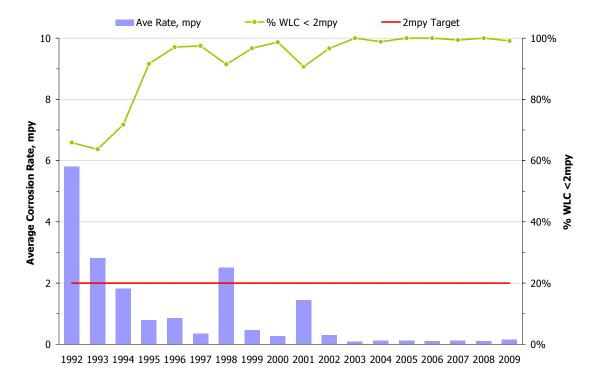
GPB Figure A.8 Corrosion Rate Trend for Majority PW System

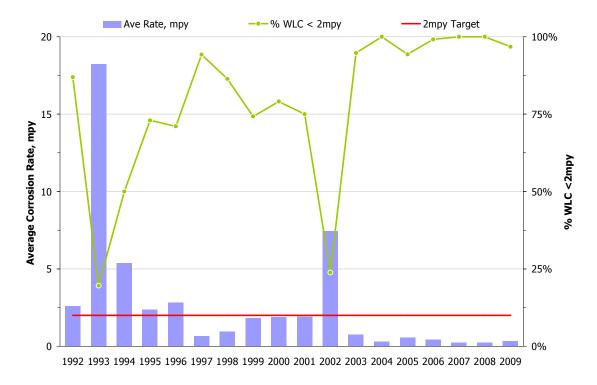
As with the PW system, the SW system data is presented as both 100% and majority service for the well line WLC data. GPB Figure A.9 and GPB Figure A.10 show the corrosion rate trends for WLC in 100% SW service and majority SW service, respectively. For 100% SW service, the improvement in average corrosion rate since 2002 was the result of implementing corrective actions outlined in previous reports. Ninety-seven percent of WLC in 100% SW service and majority SW service were below the 2 mpy target. The average pitting corrosion rates for WLC in 100% seawater and majority seawater service are also well below the 20 mpy target maximum (0.65 and 0.67 mpy respectively). It is recognized that weight loss coupons may not be statistically representative of isolated MIC mechanisms and improved means of monitoring continue to be explored.

GPB Figure A.9 Corrosion Rate Trend for 100% Seawater System

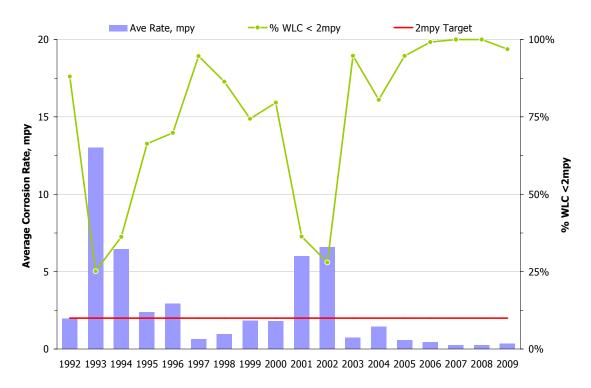
GPB Figure A.10 Corrosion Rate Trend for Majority SW System

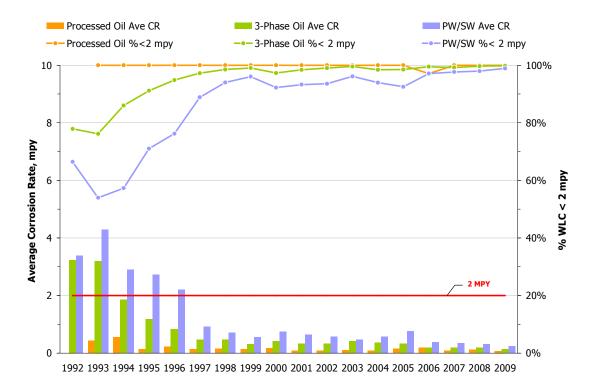
GPB Figure A.11 Flow Line Corrosion Coupon Summary by Equipment and Service

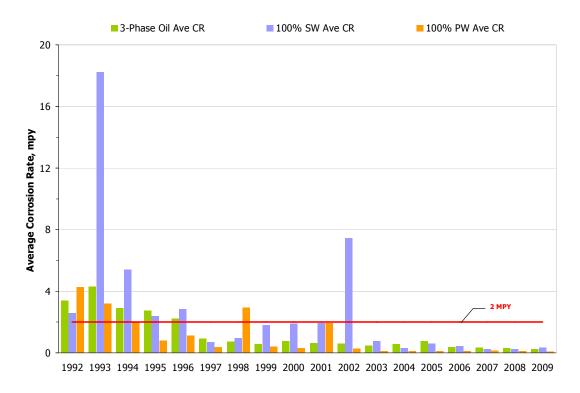
GPB Figure A.12 shows the corrosion rate and GPB Figure A.13 shows WLC corrosion conformance for well lines. Corrosion rates in the well line 3-phase system have remained low since 2000. The produced water and seawater well lines' corrosion performance has shown gradual improvement since 2002.

GPB Figure A.12 Well Line WLC Average Corrosion Rate Summary by Equipment and Service

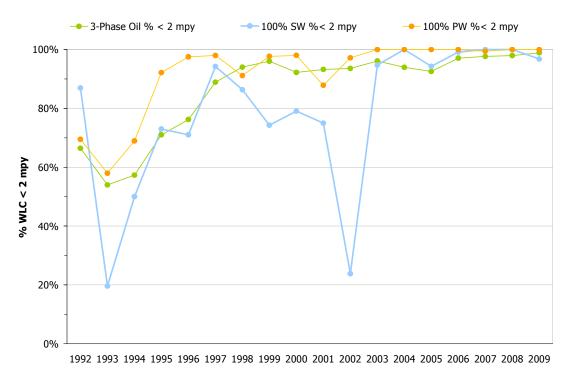
GPB Figure A.13 Well line WLC %<2 mpy Summary by Equipment and Service

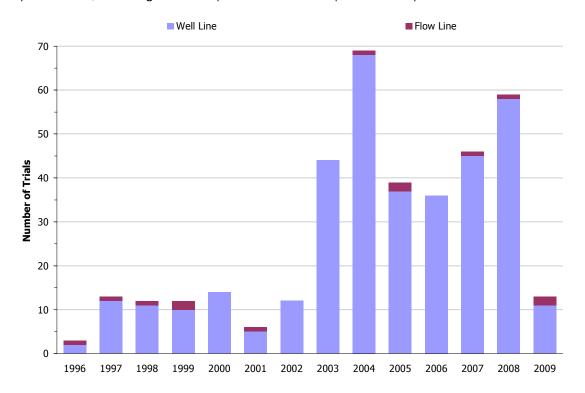
GPB Figure A.20 summarizes the number of well line and flow line corrosion inhibitor tests that have been completed since 1996. The level of well line test activity increased beginning in 2003 due to a change in the screening protocol, which reduced the time required per test. The combined number of well line and flow line tests increased from 10-14 per year to more than fifty-nine during 2008. The number of well line tests was lower this year because the corrosion inhibitor test skids are being upgraded to improve chemical metering. The test skids are expected to be completed and placed in service by mid-2010, allowing two test periods to be completed next year.

GPB Figure A.20 Number of Well Line and Flow line Tests

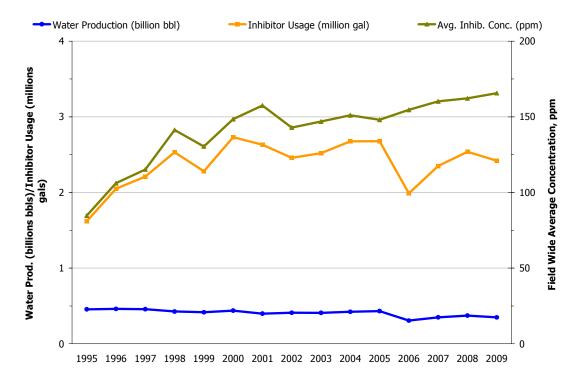
GPB Figure A.21 Field Wide Chemical Usage

While the metrics in GPB Figure A.21 deal with chemical delivery at the overall field level, chemical optimization activity primarily focuses on injecting the correct amount of corrosion inhibitor to each piece of equipment. On a local level, the inhibitor requirement is driven by factors such as water cut, water volume, flow regime, velocity and condition of the equipment. Corrosion inhibitor rates for specific equipment vary over a wide range, from a few parts per million (ppm) to several hundred ppm. For 2009 the field-wide target chemical usage was 2.40 million gallons as compared to actual field-wide usage of 2.42 million gallons.

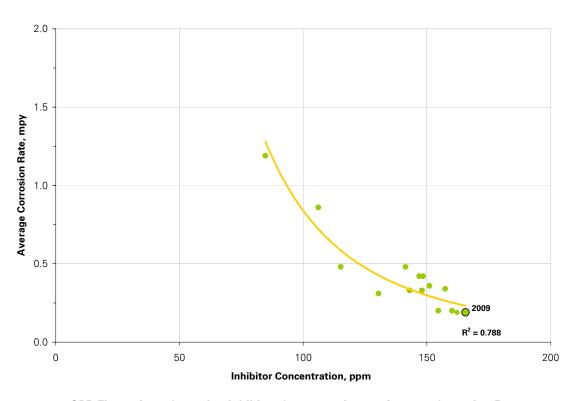
GPB Figure A.23 shows the annual field-wide average corrosion inhibitor concentrations versus annual average WLC corrosion rates for 3-phase production flow lines. The figure shows how additional corrosion inhibitor has reduced the average WLC corrosion rate through time, but also shows the minimum corrosion rate (or maximum corrosion inhibitor efficiency) achievable through inhibition is approaching an asymptote of 0.25 mpy. Maintaining the current level of performance now becomes the goal for 3-phase flow line mitigation, while addressing any corrosion rate excursions on individual lines as they occur.

GPB Figure A.23 Corrosion Inhibitor Concentration vs. Average Corrosion Rate

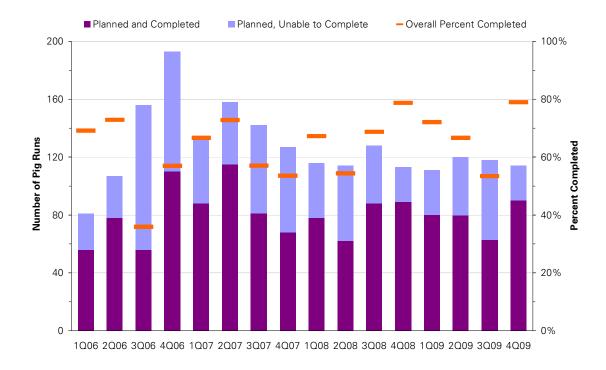
and the percent of scheduled runs completed, by year. GPB Figure A.24 shows the overall performance of the program since 2006 for scheduled pig runs on all service types. The average percentage of scheduled pig runs that were completed each year has increased for each of the last four years illustrating continuous improvement in the maintenance pigging program for GPB. For 4Q09, 79% of all scheduled maintenance pig runs were completed.

GPB Figure A.24 Maintenance Pig Runs Scheduled and Completed, All Service Types

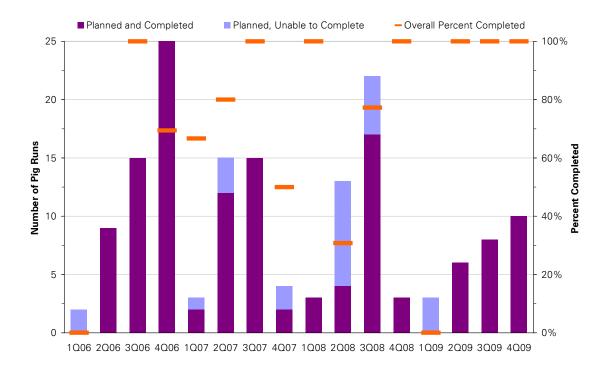
The following figures illustrate the maintenance pigging program metrics for the four major service types. GPB Figure A.25 presents the results of the maintenance pigging program for 3-phase oil lines where the annual percentage of completed runs significantly improved from 66% in 2008 to 89% in 2009. GPB Figure A.26 and GPB Figure A.27 present results for the produced water lines and processed oil lines. The maintenance pigging metrics for seawater service lines are shown in GPB Figure A.28. Although improvements were observed in the number of pig runs completed for produced water and seawater lines, equipment outages continue to challenge maintenance pig frequency objectives.

GPB Figure A.25 Maintenance Pig Runs Scheduled and Completed, 3 Phase Oil Service

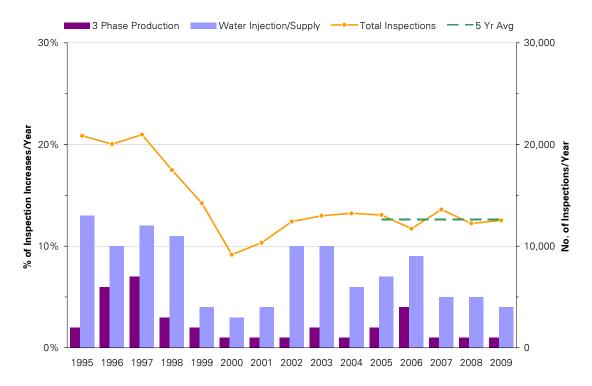
GPB Figure B.2 shows the percentage of inspection increases and the number of inspections per year for the flow lines segregated by 3-phase production and water injection (seawater and produced water) service. In 2009 the number of flow line inspections (12,538) was within 1% of the five year average.

GPB Figure B.2 Flow Line Internal Inspection Increase by Service

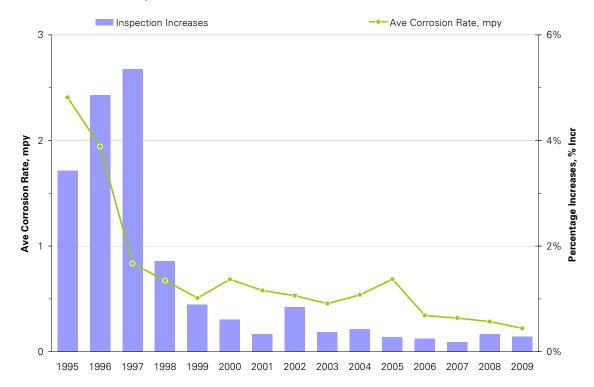
GPB Figure B.4 shows the trend for WLC average corrosion rate and the trend for percentage of inspections increases for the 3-phase well lines and flow lines. The trends for WLC and inspection results are consistent with each other and show a positive correlation. Also, the WLC trend precedes the inspection trend, as would be expected since coupons are a leading indicator. Similar trends have been observed for water service WLC and inspection data.

GPB Figure B.4 Correlation of WLC Corrosion Rate and % Inspection Increases, FL and WL 3-phase Production

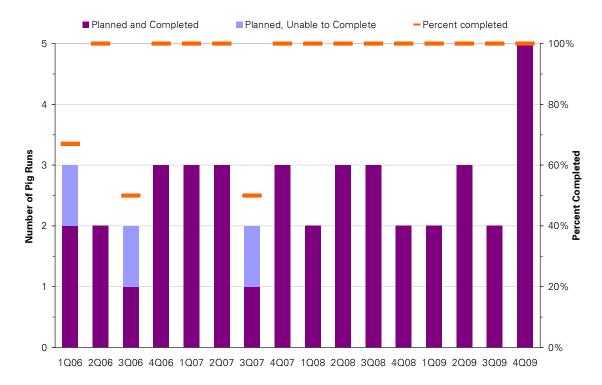
Maintenance pigging of the Endicott IIWL has been scheduled on a five-week interval. ACT Figure A.2 shows the delivery performance for the IIWL pigging by quarter beginning in 2006. In 2009, 100% of the maintenance pig runs were completed as scheduled. In addition, improvements in the maintenance pigging program were made in 4Q09 to increase the effectiveness of cleaning during the pig run and increase the frequency of pigging.

ACT Figure A.2 Endicott IIWL Maintenance Pigging Performance

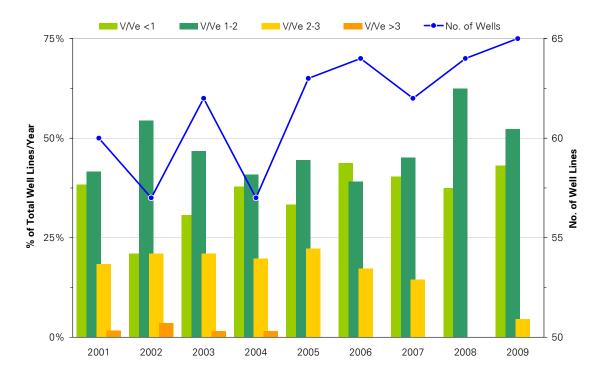
In the production system, the primary damage mechanism is erosion in the duplex stainless steel sections and corrosion in the carbon steel C-Spool sections. The erosion rate is monitored through inspection and mitigated through velocity management. Wells are risk-ranked monthly based on mixture velocity and the velocity information is used to adjust the inspection frequency and fluid velocity. ACT Figure A.3 is an overview of the average velocity data since 2001. Shown are the percent of wells within various V/V_e ratio ranges, where V is the actual mixture velocity, V_e is the velocity at which erosion becomes a concern as defined by API-RP-14E¹⁰ and V/V_e is the erosion velocity ratio.

ACT Figure A.3 Endicott Velocity Monitoring

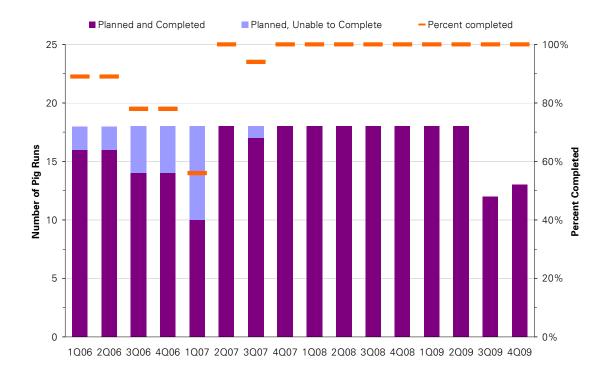
The quarterly maintenance pigging performance results for the MPU produced water lines and the 3-phase lines are shown in ACT Figure A.6 and ACT Figure A.7 respectively, for the years 2006-2009. One hundred percent of the maintenance pig runs in the produced water lines were completed on-schedule in 2009 and ninety-six percent of the maintenance pig runs in 3-phase lines were completed on schedule.

ACT Figure A.6 MPU PW Maintenance Pigging Performance

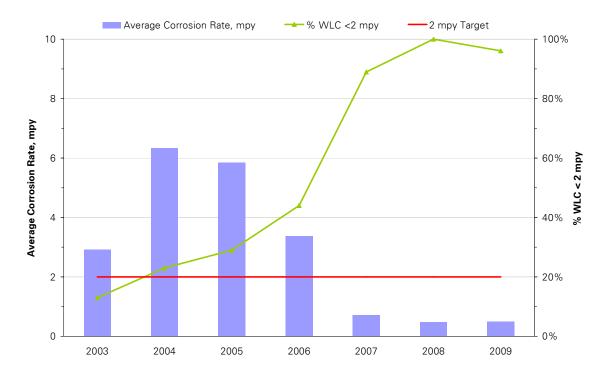
In addition to the weight loss coupon data, an electrical resistance probe is installed on the main production flow line to provide information on short term corrosion trends. The probe data is useful in correlating corrosion rate excursions to corrosion inhibitor injection rates and other operating conditions. Occasional excursions above 2 mpy have been observed during ongoing corrosion inhibitor rate optimization at the wells, however all excursions are analyzed to determine if the proper amount of inhibitor is being applied.

ACT Figure A.8 Northstar 3-Phase Oil Corrosion Rate Trend

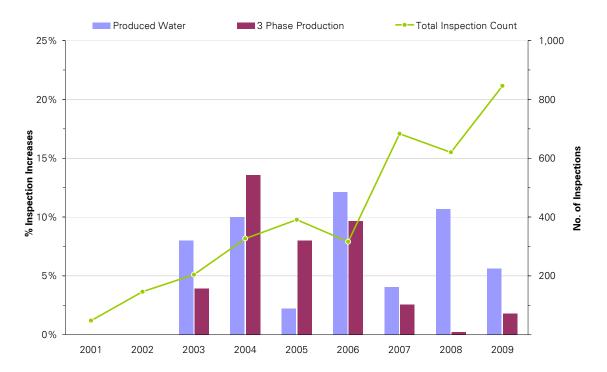
During 2009, a total of 846 well line inspections were completed on 3-phase, gas and water well line systems. The produced water disposal system showed a significant reduction in inspection increases from 11% in 2008 to 6% in 2009 (refer to ACT Figure B.7). Two percent of the inspections showed increases for the 3-phase well lines.

ACT Figure B.7 Northstar Well Line Internal Inspection Increases

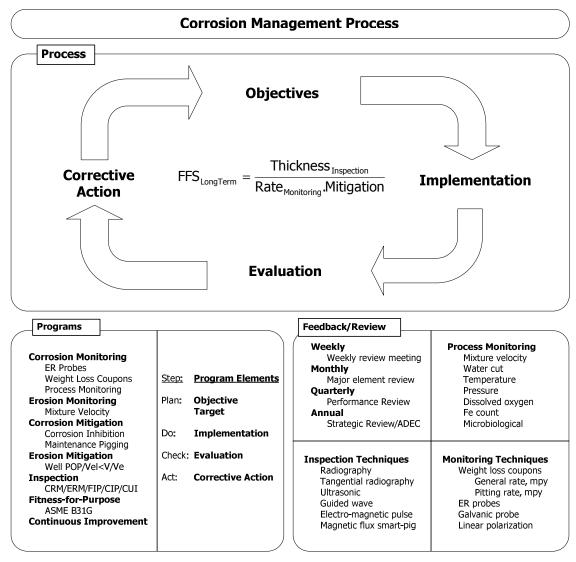
Figure 1 Overview of the Corrosion Management Process

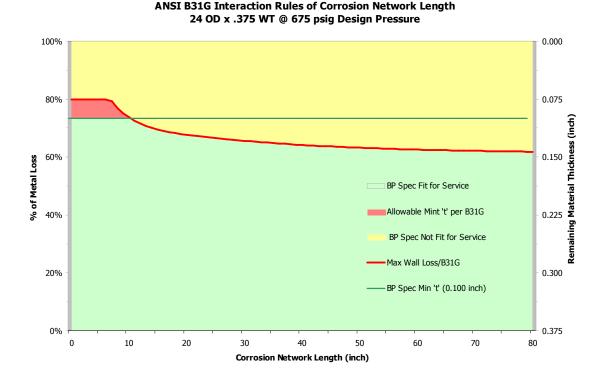
Figure 6 Fitness-for-Service Envelope Based on BP SPC-PP-00090

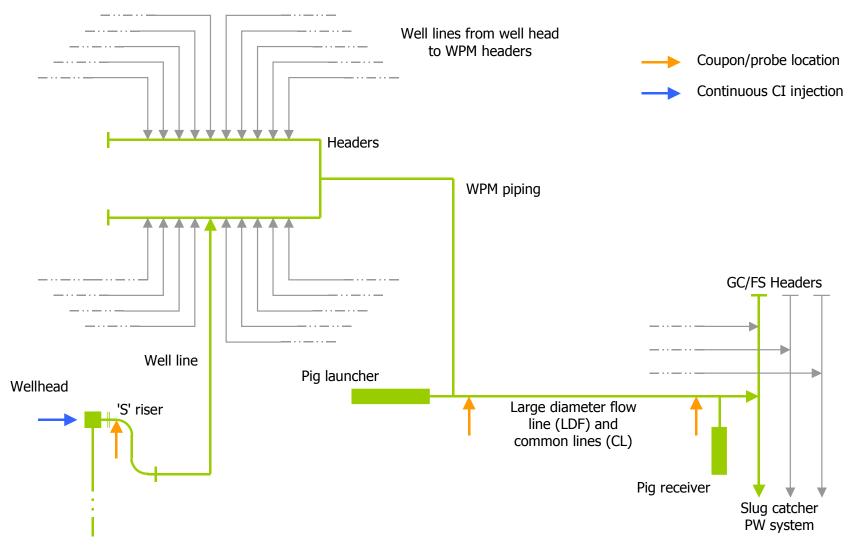
Figure 7 Facility Schematic
